Expro downhole video camera used for high temperature geothermal well intervention

Geothermal | Well Intervention

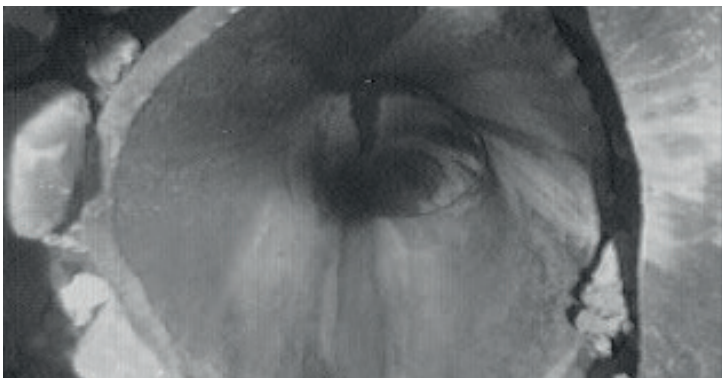
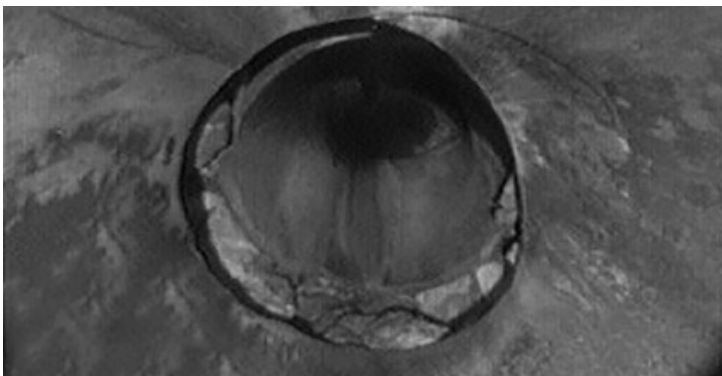
- Expro's high temperature downhole video camera was deployed to 971 feet (325°F) and confirmed the parted 13-3/8" casing, causing rock and cement entering the wellbore and trapping the logging tools
- Running additional logging tools could have potentially been caught in the split casing and either damaged or irretrievable
