/ Expro Excellence Well Intervention

Deepwater riser/BOP inspection with downhole video saves GOM operator \$1.5million as well as avoiding costly interventions in the future

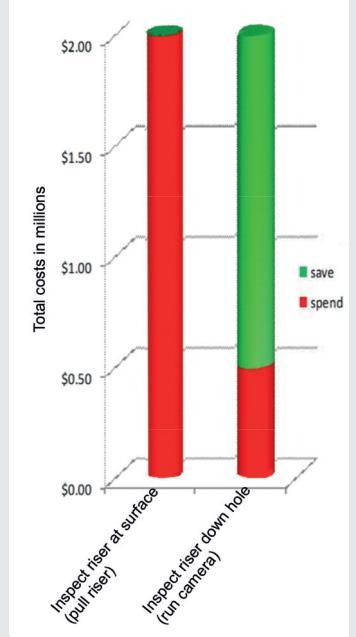
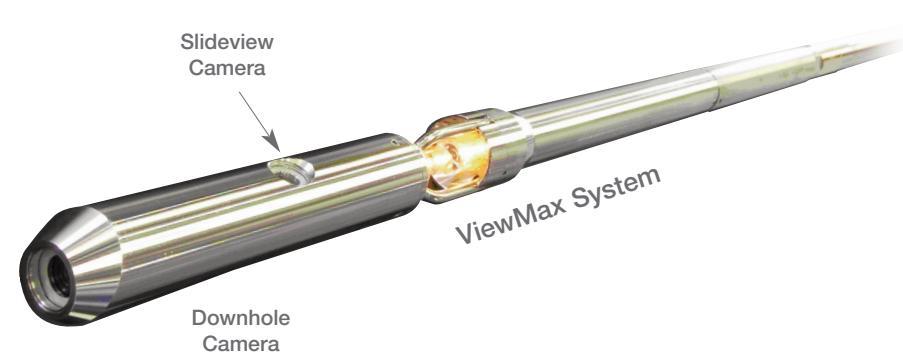
- The downhole video images were instrumental in confirming the customer had nothing to worry about and they could continue to complete their well without fear of debris falling into the well
- Avoidance of potentially undertaking a multi-million dollar intervention in the future
- Estimated savings of approx. \$1.5 million
