# / Expro Excellence Well Intervention

Expro downhole video camera used for high temperature geothermal well intervention

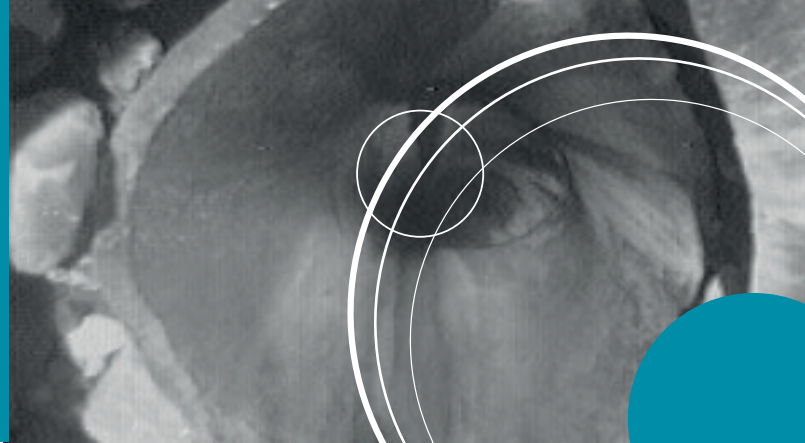
- Expro's high temperature downhole video was deployed to 971 feet (325°F) and confirmed parted 13<sup>3</sup>/<sub>8</sub>" casing, causing rock and cement entering the wellbore and trapping the logging tools
- Running additional logging tools could have potentially been caught in the split casing and either damaged or irretrievable

- Running the high temperature camera saved the client 16 hours of rig time and two runs downhole
- Visualisation of the parted casing provided detailed images of rocks and cement through the gapping split enhanced decision making for cost-effective remedial work
- The client now routinely deploys Expro's downhole video cameras within their maintenance programme (up to twice a year in older wells) due to the fluids in geothermal wells being highly corrosive – invaluable data avoids costly repairs (for example, c. \$1.5 million to repair the well or c. \$5 million to cement the well)
